# Urgent Field Update

**Topic: Drive Hang after Power Cycle**

**Date: 1/16/09**

Products: Barracuda 7200.11, Barracuda ES.2 (SATA), DiamondMax 22, FreeAgent Desk, Maxtor OneTouch 4, SV35.3, SV35.4

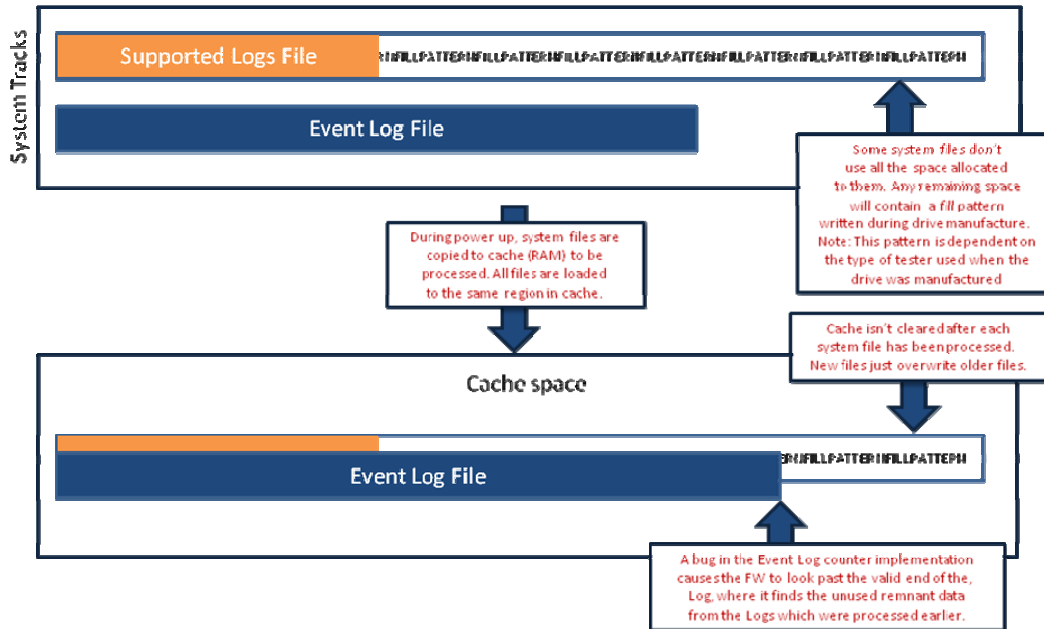
**System files are created during manufacturing, and written to the media.**

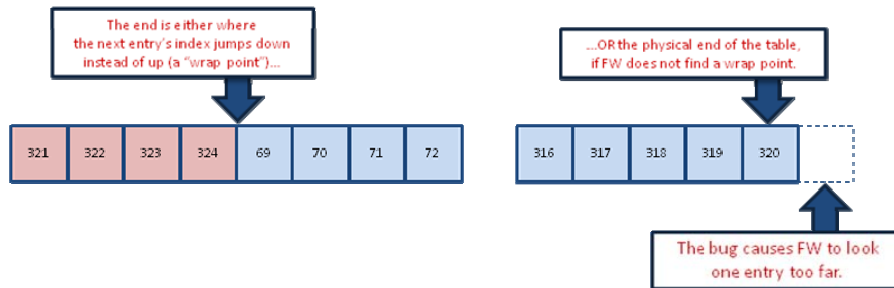
This condition is caused by a firmware bug that allows the drive's "event log" pointer to be set to an invalid location. This condition is detected by the drive during power up, and the drive goes in to failsafe mode to prevent inadvertent corruption to or loss of user data. As a result, once the failure has occurred user data becomes inaccessible.

During power up, if the Event Log counter is at entry 320, or a multiple of  $(320 + x \cdot 256)$ , and if a particular data fill pattern (dependent on the type of tester used during the drive manufacturing test process) had been present in the reserved-area system tracks when the drive's reserved-area file system was created during manufacturing (note this is not the Operating System's file system, but is instead an area reserved outside the drive's logical block address space that is used for drive operating data structures and storage), firmware will incorrectly allow the Event Log pointer to increment past the end of the Event Log data structure. This error is detected and results in an "Assert Failure", which causes the drive to hang as a failsafe measure. When the drive enters failsafe further updates to the counter become impossible and the condition will persist through all subsequent power cycles.

**The Event Log is a circular log. New entries overwrite old entries. On power up, FW looks for the most recent entry.**

Seagate has implemented a containment action in to ensure that all manufacturing test processes write a "benign" data fill pattern that does not trigger the error condition. This change is already a permanent part of the test process. All drives with a date of manufacture January 12, 2009 and later are not affected by this issue as they have been manufactured with this corrected test process. In addition, Seagate is releasing updated firmware that will make a drive immune to this failure regardless of the date of manufacture.

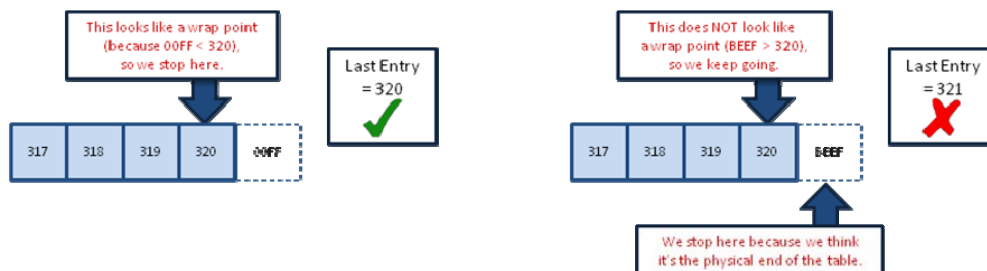
**The bug doesn't cause a failure when the erroneously referenced data looks like a valid wrap point. As a result, drives with "right" remnant pattern will work correctly in spite of the bug.**
